TECH TIPS

a technical bulletin by the experts at Gaco Western

TAKING CARE OF YOUR RIG

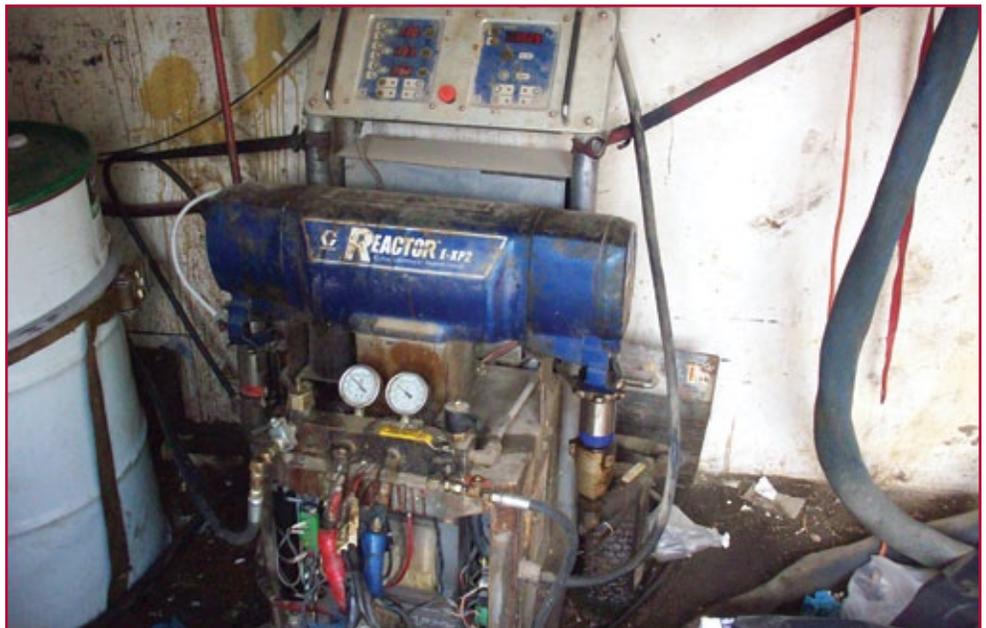
Failure to take care of your spray rig can be catastrophic to your business.

This picture above shows a reactor that was sentenced to death row. It is strapped to the wall, surrounded by filth and debris, and the lower housing door is left wide open while the door is shoved behind the machine. If you look on the fluid manifold you'll notice the older style pressure relief valve with one missing on the "A" side. This reactor has ball valves coming off of the fluid manifold to control pressure instead of the pressure relief valves which also act as a safety feature unlike

the ball valves. While these machines can take the rigors of the work load, if not properly maintained it becomes a safety hazard and a ticking time bomb.

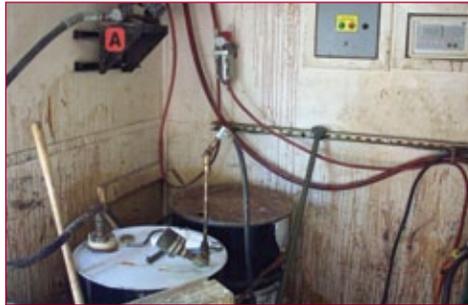
In the picture on page 2 you can see how raw "A" material has been carelessly splattered all over the wall and on the drums and the floor. As you know, over time this material crystallizes with the moisture in the air and leaves stains on everything. From the picture you can also see how well the drum is vented allowing moisture and debris into the drum. Against the wall you will notice the

gray handled boat oar which is used to stir the "B" side material, which requires taking the lid off the drum and potentially allowing more debris into the system. These types of practices are harmful to filters and high pressure seals and to the overall performance of the equipment.

These pictures clearly demonstrate the lack of maintenance and basic care it takes to maintain an efficient operating spray rig. Rigs like these are the ones that always have issues with foam performance or are broke down at the job site. Become more informed about your rig and the dangers of poor maintenance. Seek out the training that is available from your spray rig manufacturer and chemical supplier. Care about your employees and your investment in the spray rig. Someone who calls themselves a professional spray polyurethane foam installer should never show up at a jobsite with a rig looking like this.

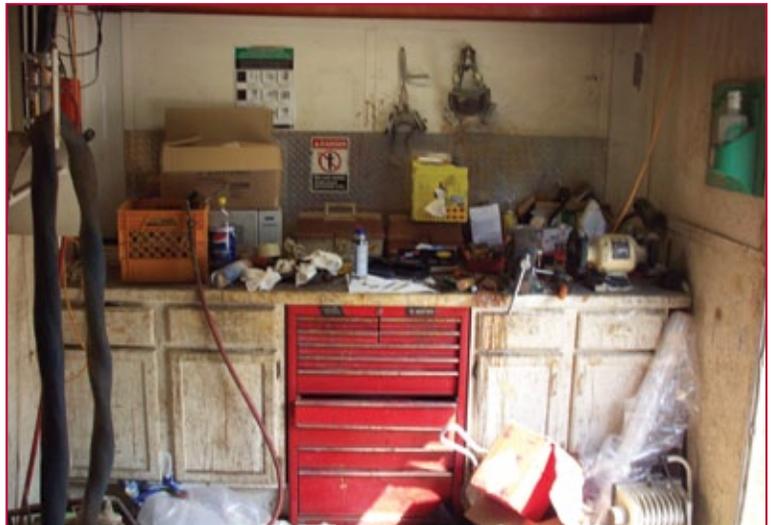
This is an example of bad housekeeping which can result in unsafe work areas and loss of newly purchased materials that are needed to complete job tasks. With all the clutter across the top of the work bench how can you even

rebuild or clean a gun? Look around the floor at all the debris piled up to the point where you can't even open the cabinet doors. The APR respirators are just hanging on the wall and not in sealed bags stored properly. There is an eye wash bottle on the wall but it is only half full.
