Case History

Type of Project / Name:	Combination Metal & Built-Up Roof Restoration / Goodyear Airport
Location:	Goodyear, AZ
Specification:	RC-MR-GF20 (GacoFlex S20 Silicone)
Contractor:	Todd Conner, Progressive Roofing
Customer:	Sky Harbor Airport Facilities and Services
Problem to be Solved:	Existing roof was not able to bear any additional weight.

Goodyear Airport chooses **GacoFlex S2000** *instead of a new roof.*

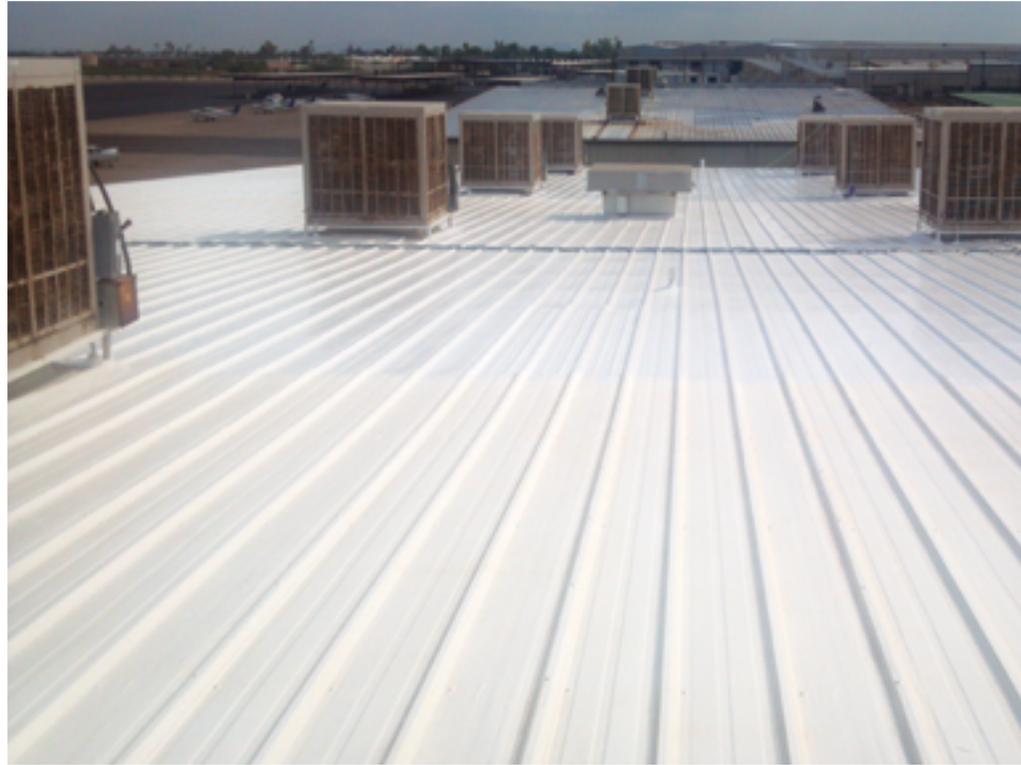
PROBLEM: Goodyear Airport, managed by Sky Harbor Airport Facilities and Services, was experiencing roof leaks caused by ponding water on their 75,000 square foot metal hangar. The building also has a 35,000 square foot built-up roof portion.

Structural engineers warned against applying any additional weight onto the metal roof which meant the airport was likely looking at a very expensive complete roof replacement.

SOLUTION: The GacoFlex Area Manager worked extensively with Sky Harbor Facilities to provide the proper specification to coat the metal roof as well as the built-up roof. GacoFlex S20 Series Solvent-Free 100% Silicone Coating was the best solution and additional roof weight wouldn't be a concern: GacoFlex S20 Series Coatings weight only 0.2 pounds per square foot which is less than the weight of rain.

The Goodyear Airport was able to re-coat their roof instead of replacing it and they can remain confident it will remain leak-free with a 10 year Labor and Materials Warranty.

Goodyear Airport was able to save the roof without adding additional weight to the structure; their cost savings were significant compared to the cost of replacing the entire metal roof.

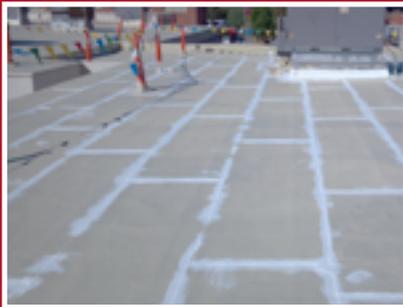
Before: built-up roof section.

INSTALLATION DETAILS: The roof surface was thoroughly cleaned with GacoFlex D09 and then primed with GacoFlex E5320 2-Part Epoxy Primer/Filler. GacoFlex SeamSeal was used to seal joints and then two coats of GacoFlex S2000 Solvent-Free 100% Silicone Coating was applied.

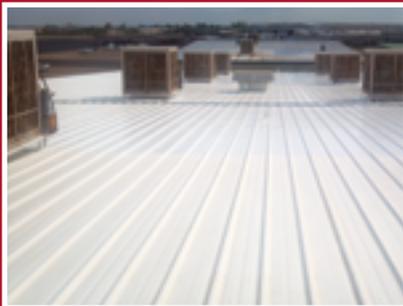
After: metal roof section.
